TEST REPORT

REPORT No.:
CTK-2024-00278
Page (1) / (13) pages

NETWORK CAMERA / TNV-C8011RW

KS C IEC 62262: 2005

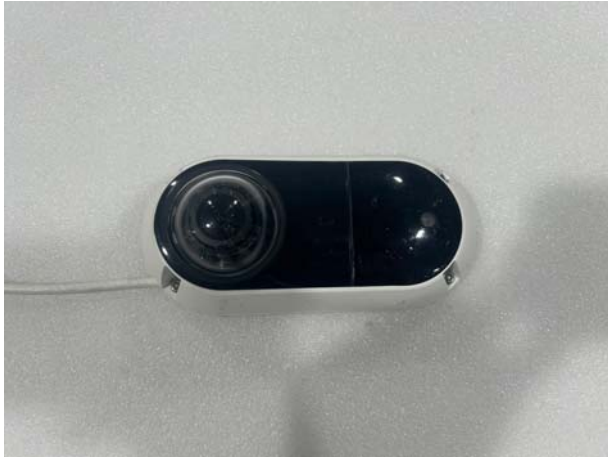
Top

Evaluation Criteria		Test Results	Comment
Visual Inspection	Pre-test	No problem with the product	-
	Post-test	Some scratches were generated on the outside of the product.	-
