# TEST REPORT

Report No.:  
CTK-2023-02366  
Page (1) / (18) pages

: NETWORK CAMERA / XNP-C9310R

7. Test Standard (Method) used : IEC 60529:1989 +A1:1999+A2:2013

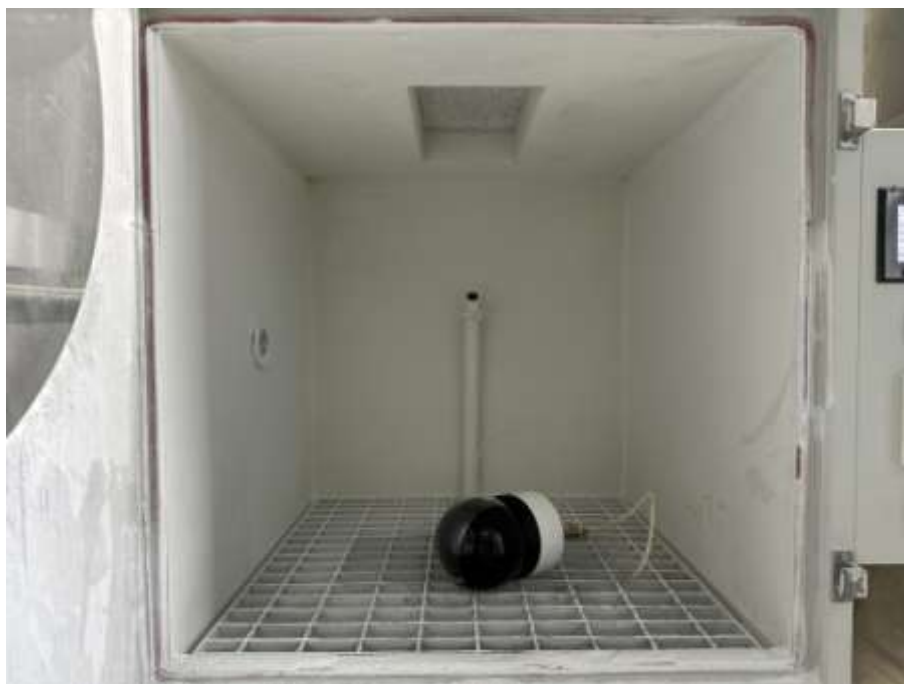
### < Photo 3 > The First Characteristic Numeral Test

First characteristic numeral	Degree of protection	Application
6	Protected against access to hazardous parts with a wire. The access probe of 1.0 mmØ, shall not penetrate. Test force: 1 N ± 10 %	<input checked="" type="checkbox"/>

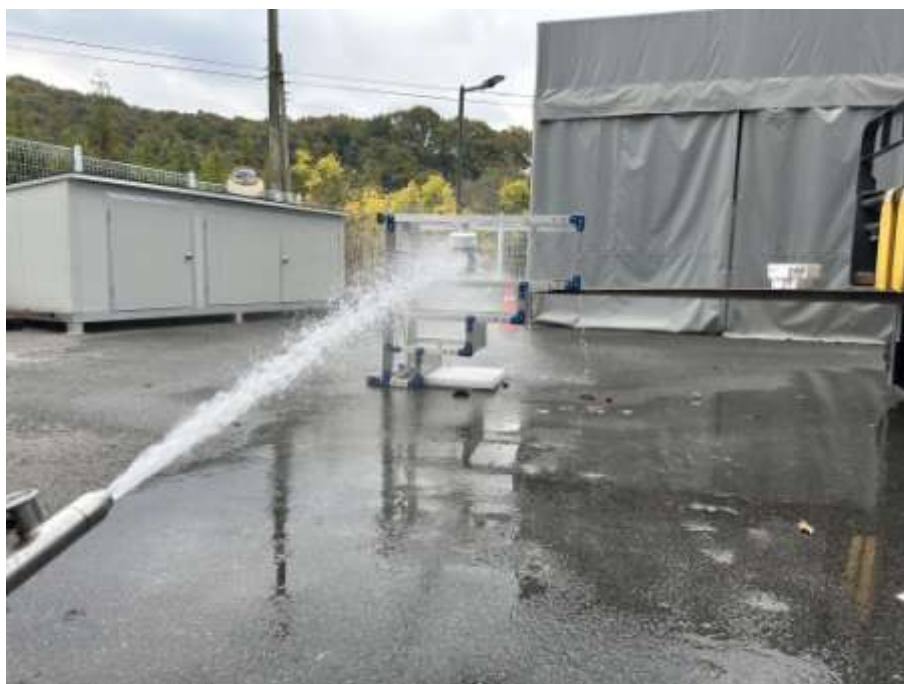
### < Photo 4 > The Second Characteristic Numeral Test

Second characteristic numeral	Degrees of protection	Application
6	<p>The product must not be harmed in any direction even strong jet water.</p> <p>Water jet hose nozzle Fig.6, Nozzle 12.5 mm diameter</p> <p>Water flow rate: 100 l/min <math>\pm</math> 5 % : <b>100 LPM</b></p> <p>Distance: 2.5 m to 3 m: <b>3 m</b></p> <p>Duration of test: 1 min/m<sup>2</sup> at least 3 min: <b>3 min</b></p>	<input checked="" type="checkbox"/>

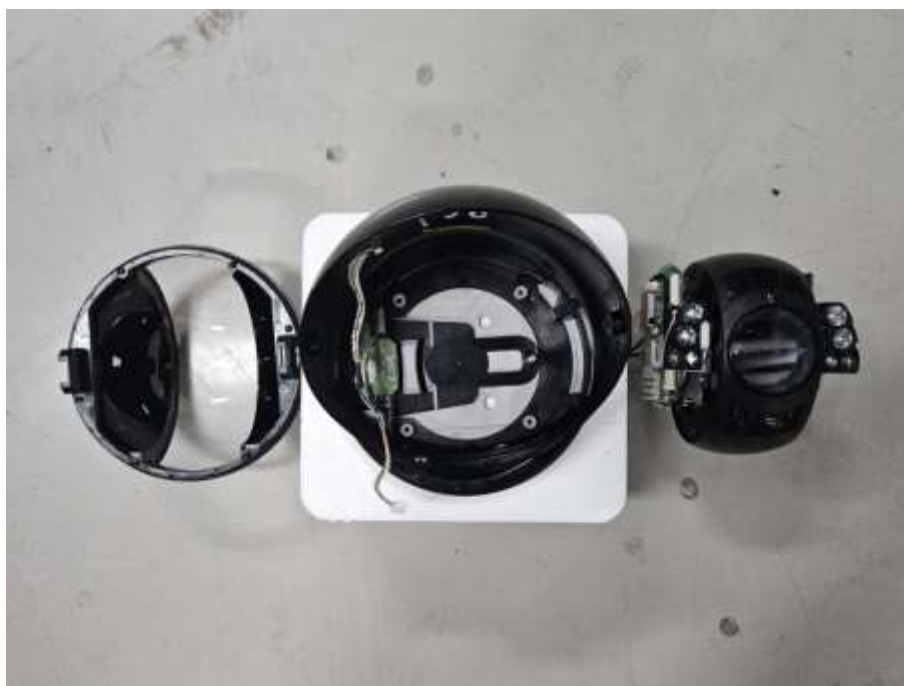
### < Photo 5 > The First Characteristic Numeral Test

IP Code	Remark
IP 6X	No penetration of probe. No ingress of dust.
IP X6	No ingress of water.

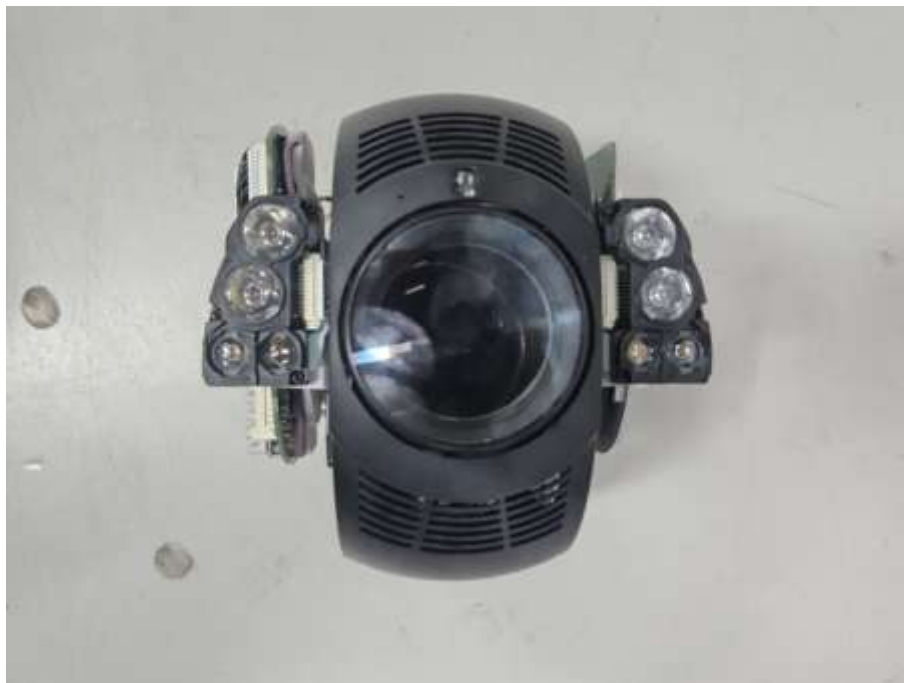
**< Photo 7 > The First Characteristic Numeral Test**

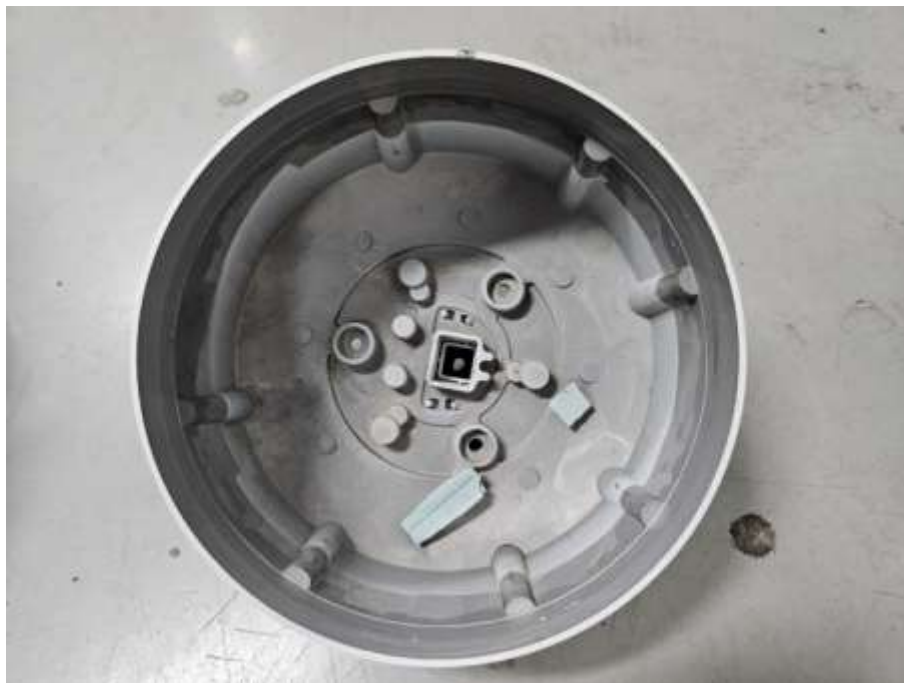
**< Photo 11 > The First Characteristic Numeral Test**

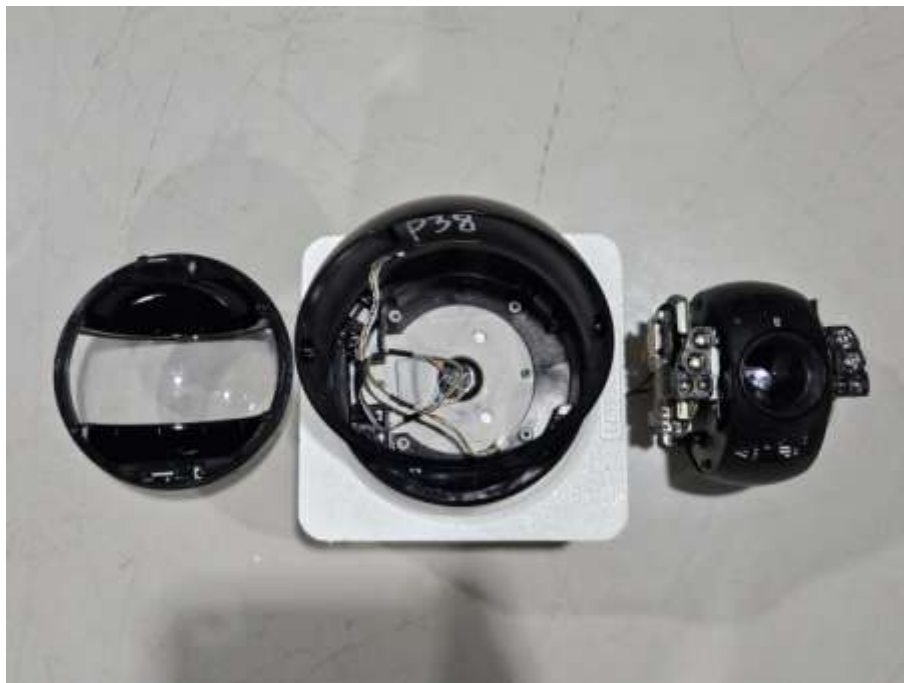
**< Photo 12 > The Second Characteristic Numeral Test**

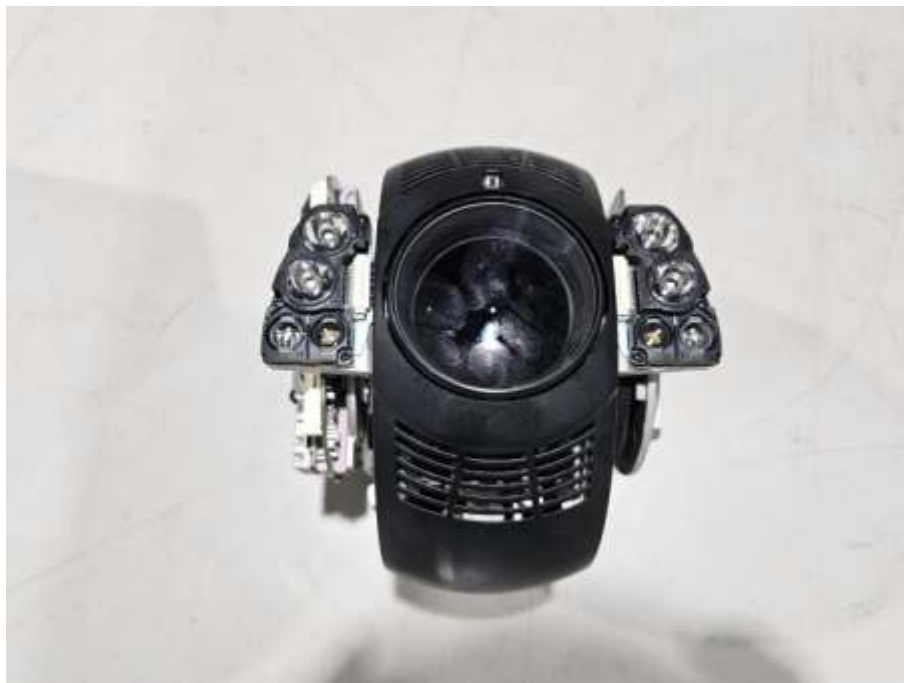
**< Photo 14 > The Second Characteristic Numeral Test**

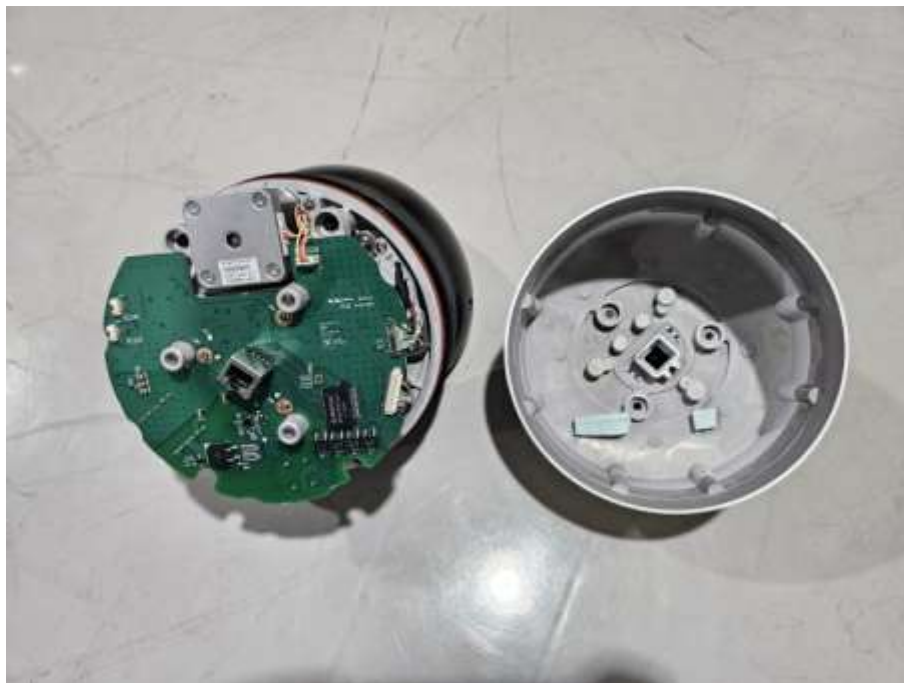
**< Photo 16 > The Second Characteristic Numeral Test**

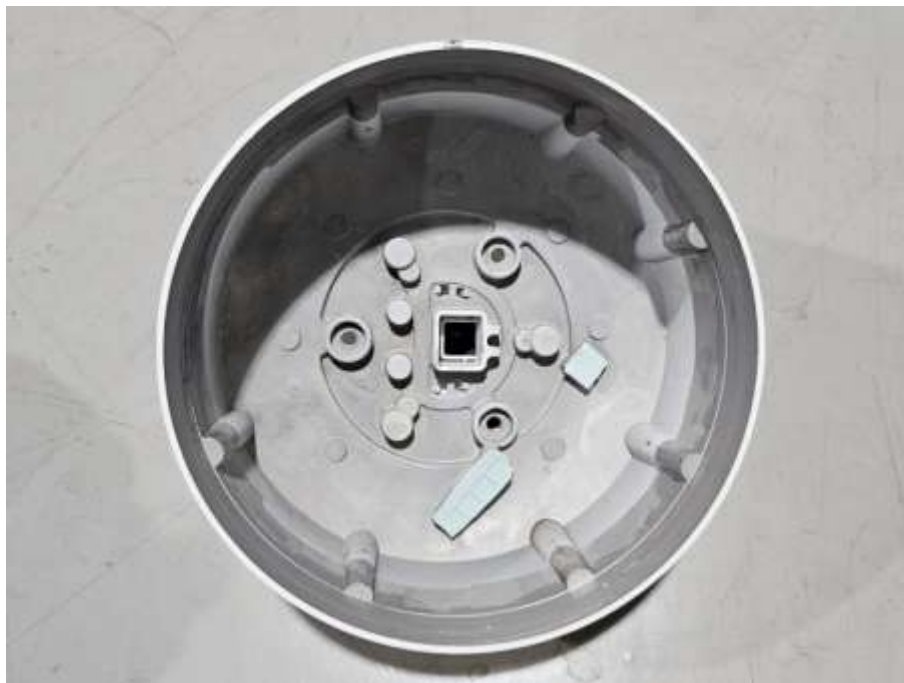
**< Photo 18 > The Second Characteristic Numeral Test**
